IMACS SITE FORM

4. State Utah State Code 42 County Summit County Code SM
 5. Project Victory Ranch Phase III P-III Associates Project No. 5196
 *6. Agency Report No. U-03-PD-0248p P-III Associates Report No. 5196-01-20305
 *7. Site Name / Property Name Prescott Ranch / Victory Ranch Bridge

4. State Utah State Code 42 County Wasatch County Code WA
 5. Project Victory Ranch Phase III P-III Associates Project No. 5196
 *6. Agency Report No. U-03-PD-0248p P-III Associates Report No. 5196-01-20305
 *7. Site Name / Property Name Larsen, Rasmus and Annie Minnie Jensen Farmstead

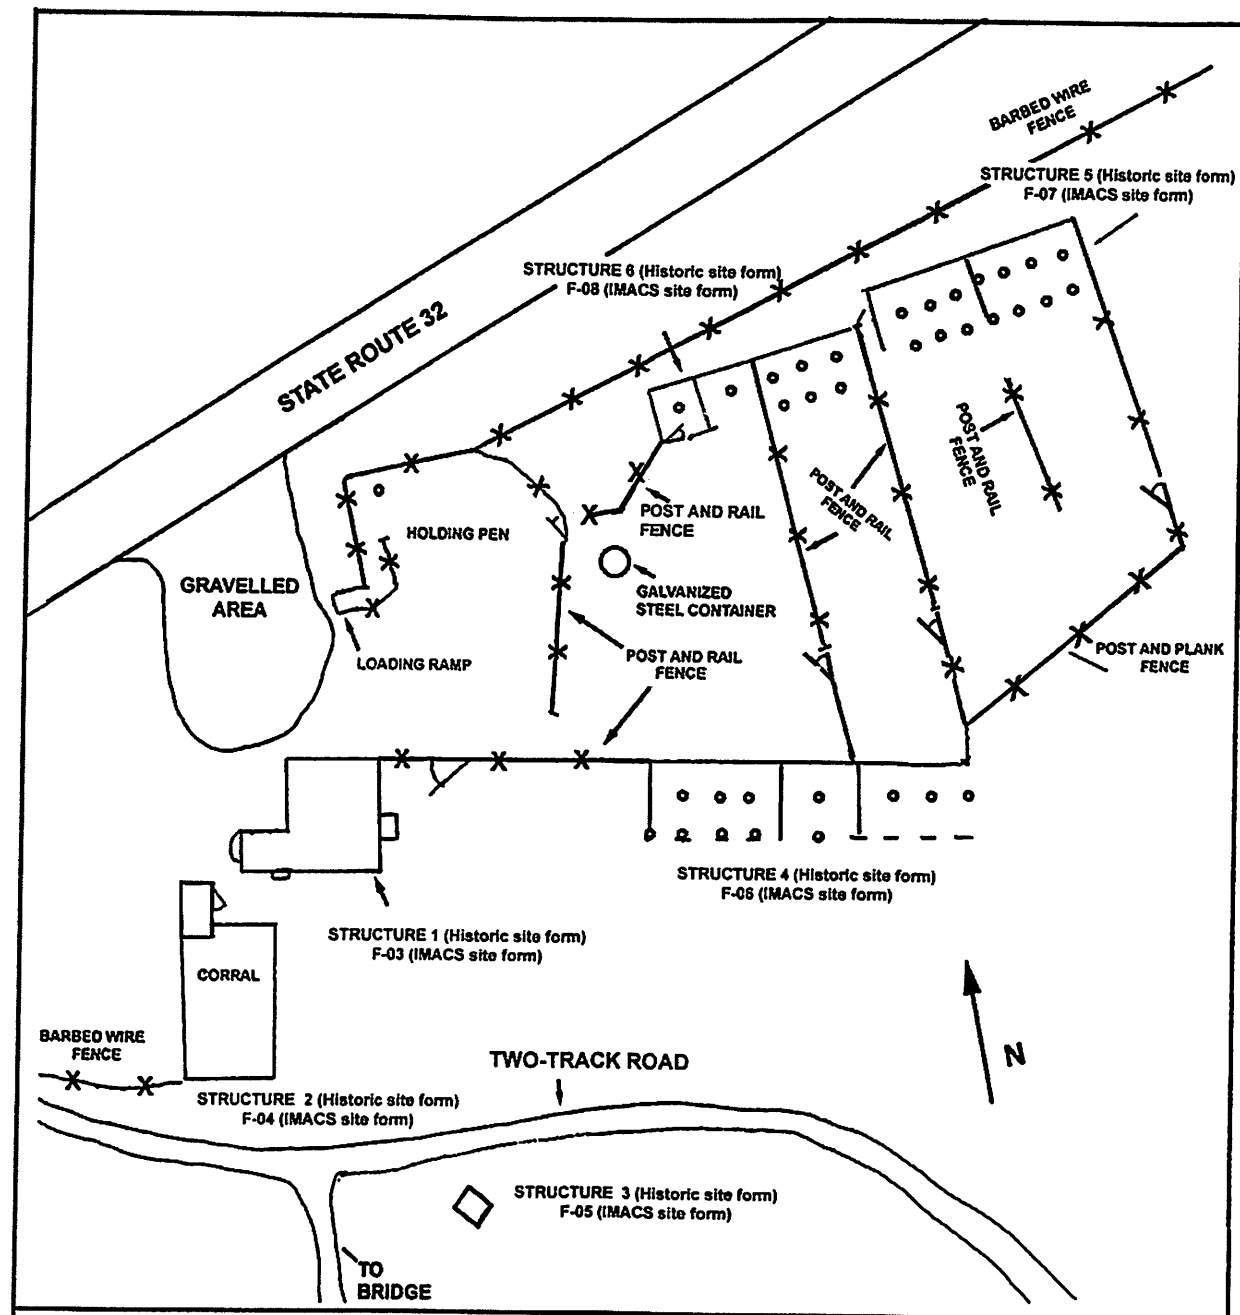
Site 42WA324
Larsen Farmstead
(Larsen Ranch Complex)
Plan Map

The site has been impacted by erosion, a two-track road, vandalism, grazing, rodent burrowing, fencelines, and vegetation growth. The earlier barn (F-01) is in poor condition and is currently in danger of collapsing to the south. An associated pen (F-02) is collapsed and two associated corrals are in poor condition. The red barn (F-03) is still standing and is structurally sound; however, portions of the roof have collapsed and the interior is covered in cow manure. The pens and structures associated with the red barn (F-04 to F-08) are in fair to good condition. The bridge (F-09) is in good condition, although the eastern end of the central concrete bridge support has sunk slightly into the bed of the Provo River. The collapsed corral (F-10) is in poor condition. The stockpond (F-12) and irrigation ditch (F-11) are currently not in use and are in fair to good condition. The small house (F-13) retains structural integrity and is in fair condition. A tree has fallen across the rear portion of the structure since the initial architectural documentation. The garage (F-14) is in good condition. The pump house (F-16) and the root cellar (F-15) have collapsed roofs and portions of the walls are also collapsed. They are in fair condition. The rubble pile (F-17) represents the remains of a destroyed house obviously in very poor condition. The outhouse depression (F-18) is in fair condition, although there is no evidence of the original superstructure. The remainder of the site has little evidence of any disturbance and is in good condition.
